DOT/FAA/AR-95/51

# Nondestructive Inspection of Piper PA-25 Forward Spar Fuselage Attachment Fitting

September 1995

Final Report

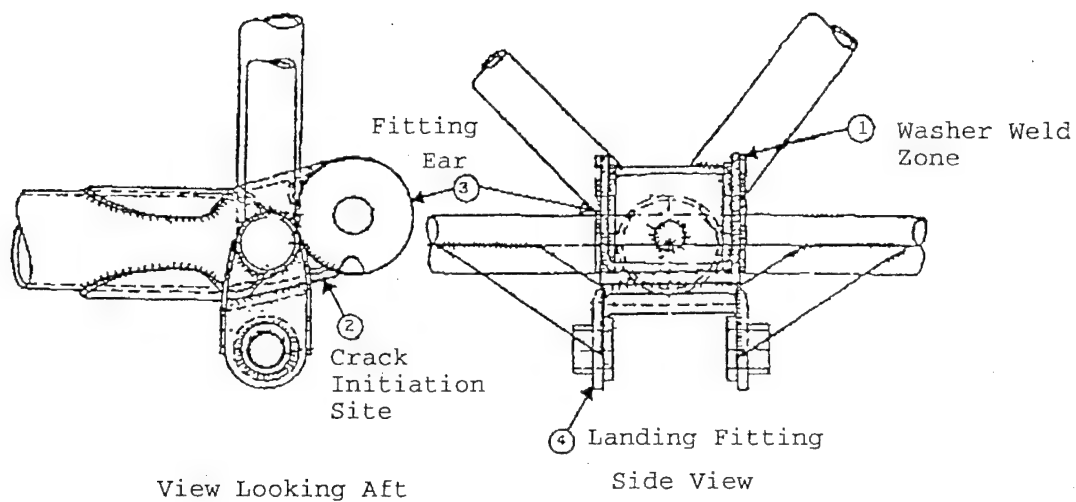
FIGURE 1. VIEW LOOKING AFT AND A SIDE VIEW OF THE SPAR ATTACHMENT FITTING FOR THE PIPER MODEL PA-25-150. FIGURE WAS TAKEN FROM AD 93-21-12.

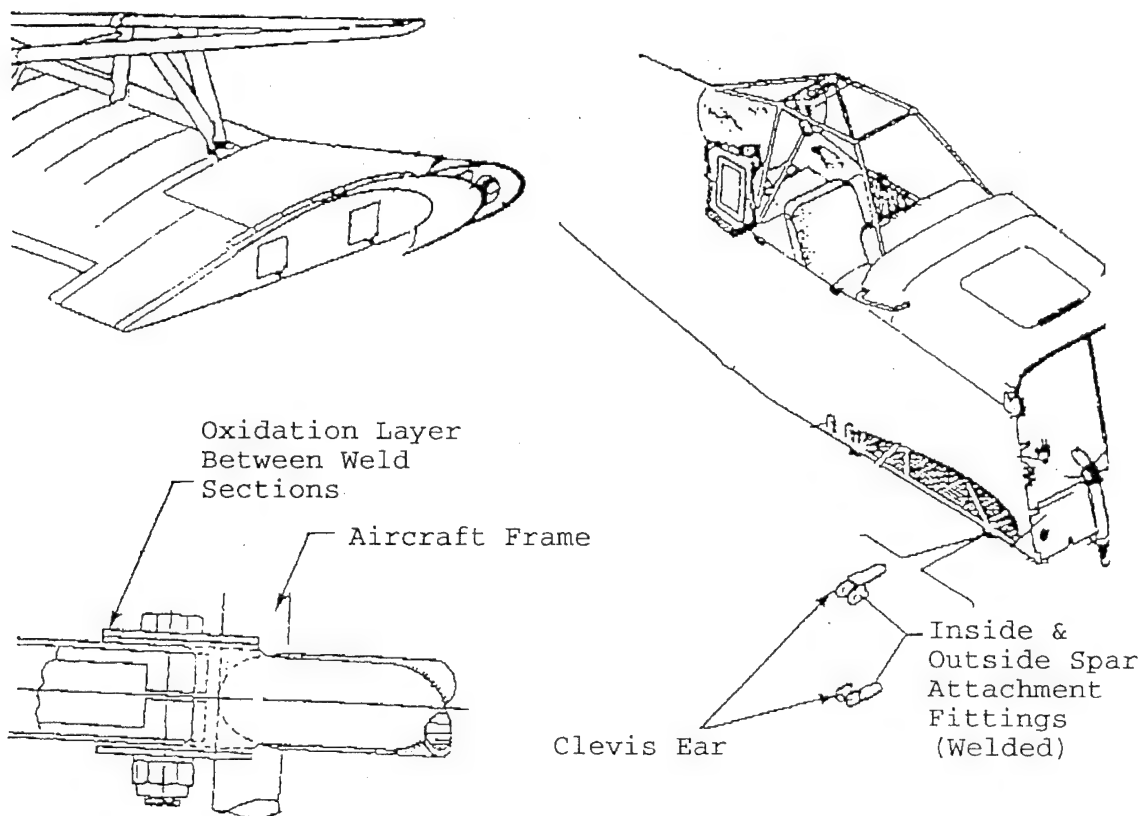
FIGURE 2. LOWER ATTACHMENT FITTING EAR AS ASSEMBLED IN THE PRESENT CONFIGURATION. FIGURE WAS TAKEN FROM AD-93-21-12.

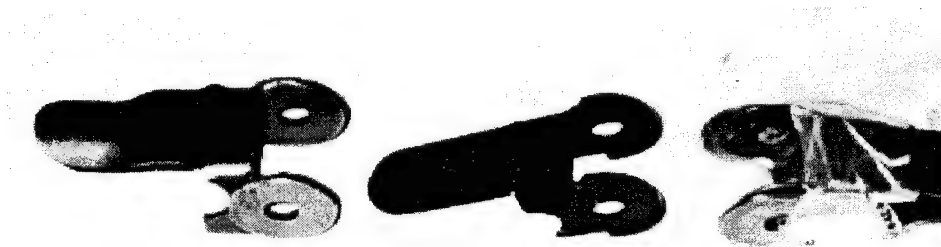
On March 4, 1994, two forward attachment spar clusters and a new Piper manufactured fitting were received from the Atlanta ACO. Sample 1 was a new, fully assembled ear fitting. To help understand the current welding process, two subassembly piece parts were also sent (figure 5). Sample 2 was a forward spar fuselage attachment cluster which had extensive pitting and surface

FIGURE 5. SAMPLE 1 - A NEW, FULLY ASSEMBLED EAR FITTING (FAR LEFT) AND TWO SUBASSEMBLY PARTS.
